Manhole Inspection Summary

Manhole # S29E__018MH

Insp Date: **1/20/09 11:30 AM**

Location Address: **210 N.Pine St.**

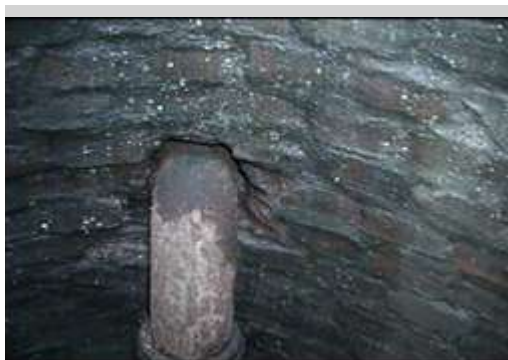
Miscellaneous

service line in manhole

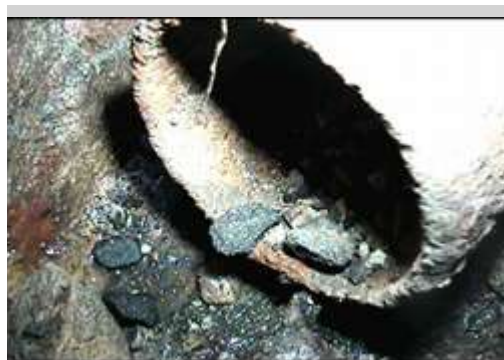
Miscellaneous

service line

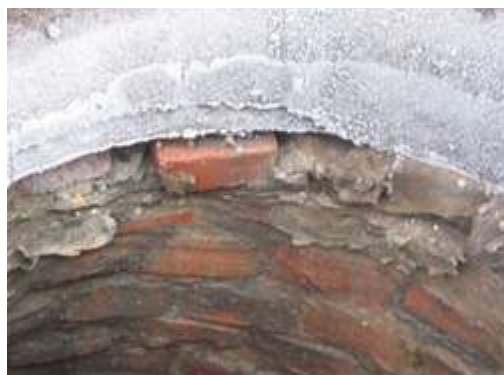
Defect 4

Condition: ☐ Sound ☐ Cracked ☐ Root Intrusion ☒ **Loose Brick** ☒ **Deteriorated**

Infiltration: ☐ None ☒ **Joint** ☐ Cracks ☒ **Mortar** ☐ Roots ☐ Wall

chimney deteriorated & loose brick with infiltration from mortar & joint

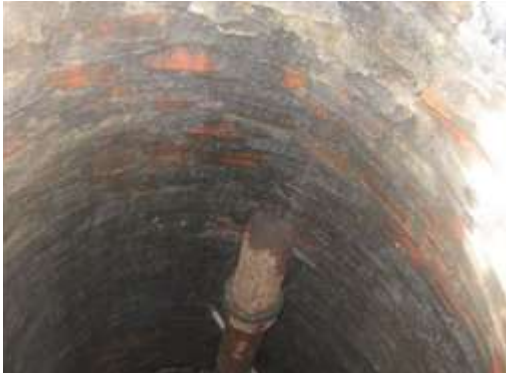
Defect 5

Infiltration: ☐ None ☐ Joint ☐ Cracks ☒ **Mortar** ☐ Roots ☒ **Wall**

corbel infiltration from mortar & wall

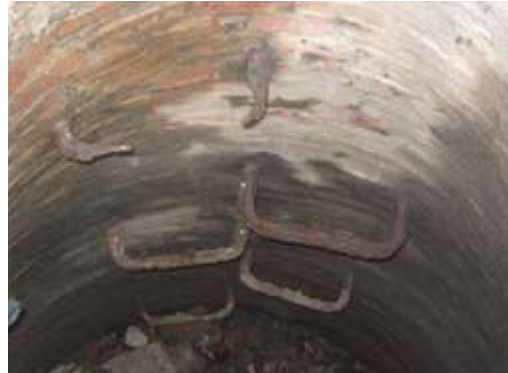
Defect 3

Count: **6** Missing: **1** ☒ **Corroded**

corroded rungs and 1 missing

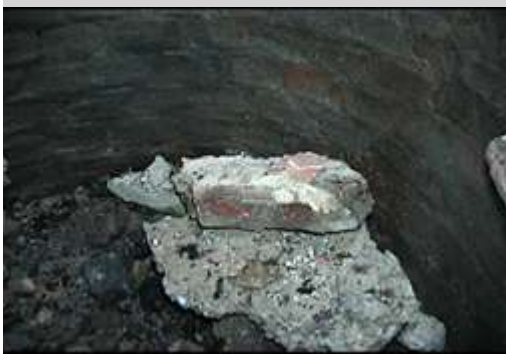
Defect 1

Condition: ☐ Sound ☐ Cracked ☐ Root Intrusion ☐ Deteriorated ☐ Leaks ☒ **Debris**

channel debris
